Manhole Inspection Summary

Manhole # S21G1_019MH

Insp Date: **4/13/08 1:21 PM**

Location Address: **2806 hololins ferry rd**

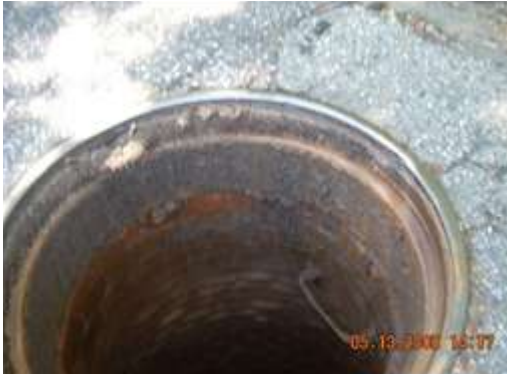
Defect

Condition: ☐ Sound ☐ Cracked ☒ **Leaks**

inflow evidence

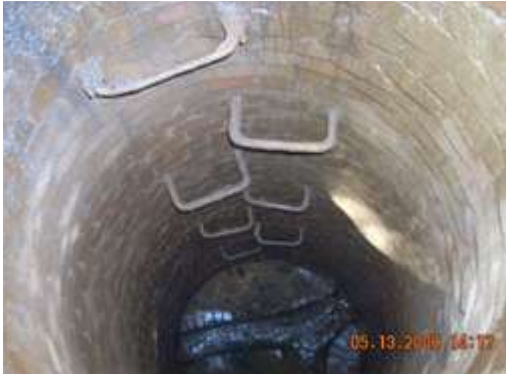
Defect 2

Steps Count: **8** Missing: **0** ☒ **Corroded**

corroded steps

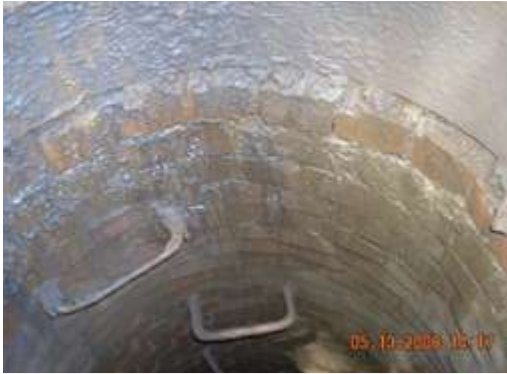
Defect 1

Infiltration: ☐ None ☒ **Joint** ☐ Cracks ☐ Mortar ☐ Roots ☐ Wall

infiltration @ chimney/frame joint

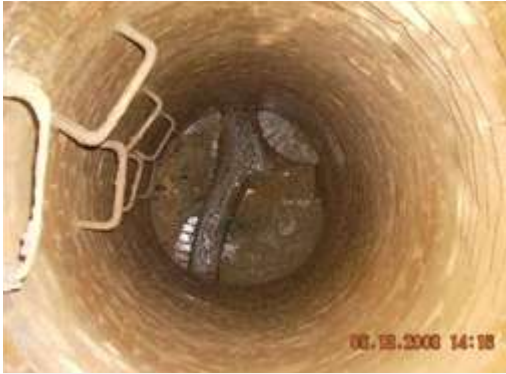
Defect 3

Condition: ☐ Sound ☐ Cracked ☐ Root Intrusion ☐ Deteriorated ☐ Leaks ☒ **Debris**

Channel and Bench Debris

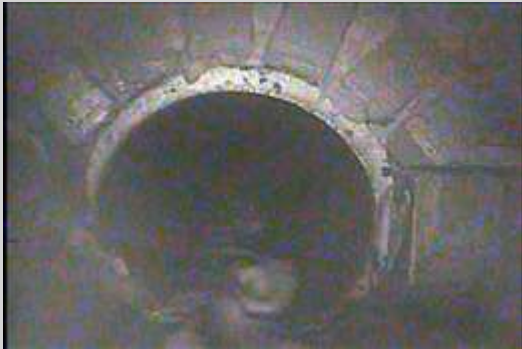
12 O'Clock Outflow

Pipe Height: **10.8** (in.) Rod and Bar (Angled)
Pipe Material: **Clay** ☐ Pipe Lined
Invert Depth: **13.75** (ft.) Flow Characteristics: **Fast**
Deposits: ☒ None ☐ Mud ☐ Sludge ☐ Debris ☐ Grease
Silt Depth: **0** (in.) Deposits Extent:
Infiltration: **None** Pipe Seal Cond: **Sound**

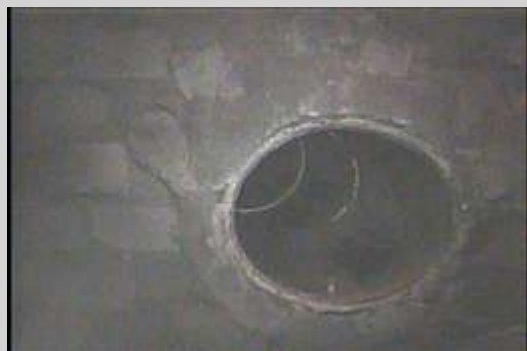
Pipe In @ 6 OClock

Pipe Height: **8.4** (in.) Rod and Bar (Angled)

Pipe Material: **Clay** ☐ Pipe Lined

Invert Depth: **8.78** (ft.) Flow Characteristics: **Fast**

Deposits: ☒ None ☐ Mud ☐ Sludge ☐ Debris ☐ Grease

Silt Depth: **0** (in.) Deposits Extent:

Infiltration: **None** Pipe Seal Cond: **Sound**

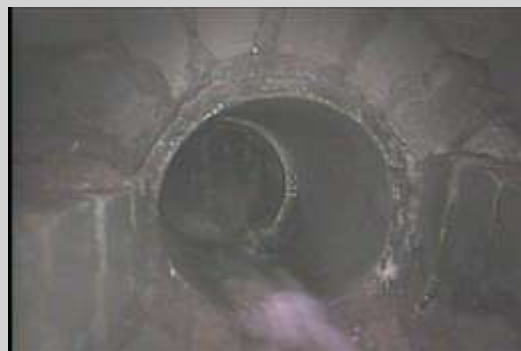
Drop In @ 6 OClock

Drop: **Outside** Rod and Bar

Angled: **Yes** Reading: **12.40** (ft.)

Inv Depth: **13.40** (ft.)

Drop Condition: **Open**
